**REFINEMENT OF PROMISING COATING COMPOSITIONS  
FOR DIRECTIONALLY CAST EUTECTICS**

**FINAL REPORT**

UNITED TECHNOLOGIES CORPORATION  
Pratt & Whitney Aircraft Group  
Commercial Products Division

NATIONAL AERONAUTICS AND SPACE ADMINISTRATION  
NASA-Lewis Research Center  
Contract NAS3-18920

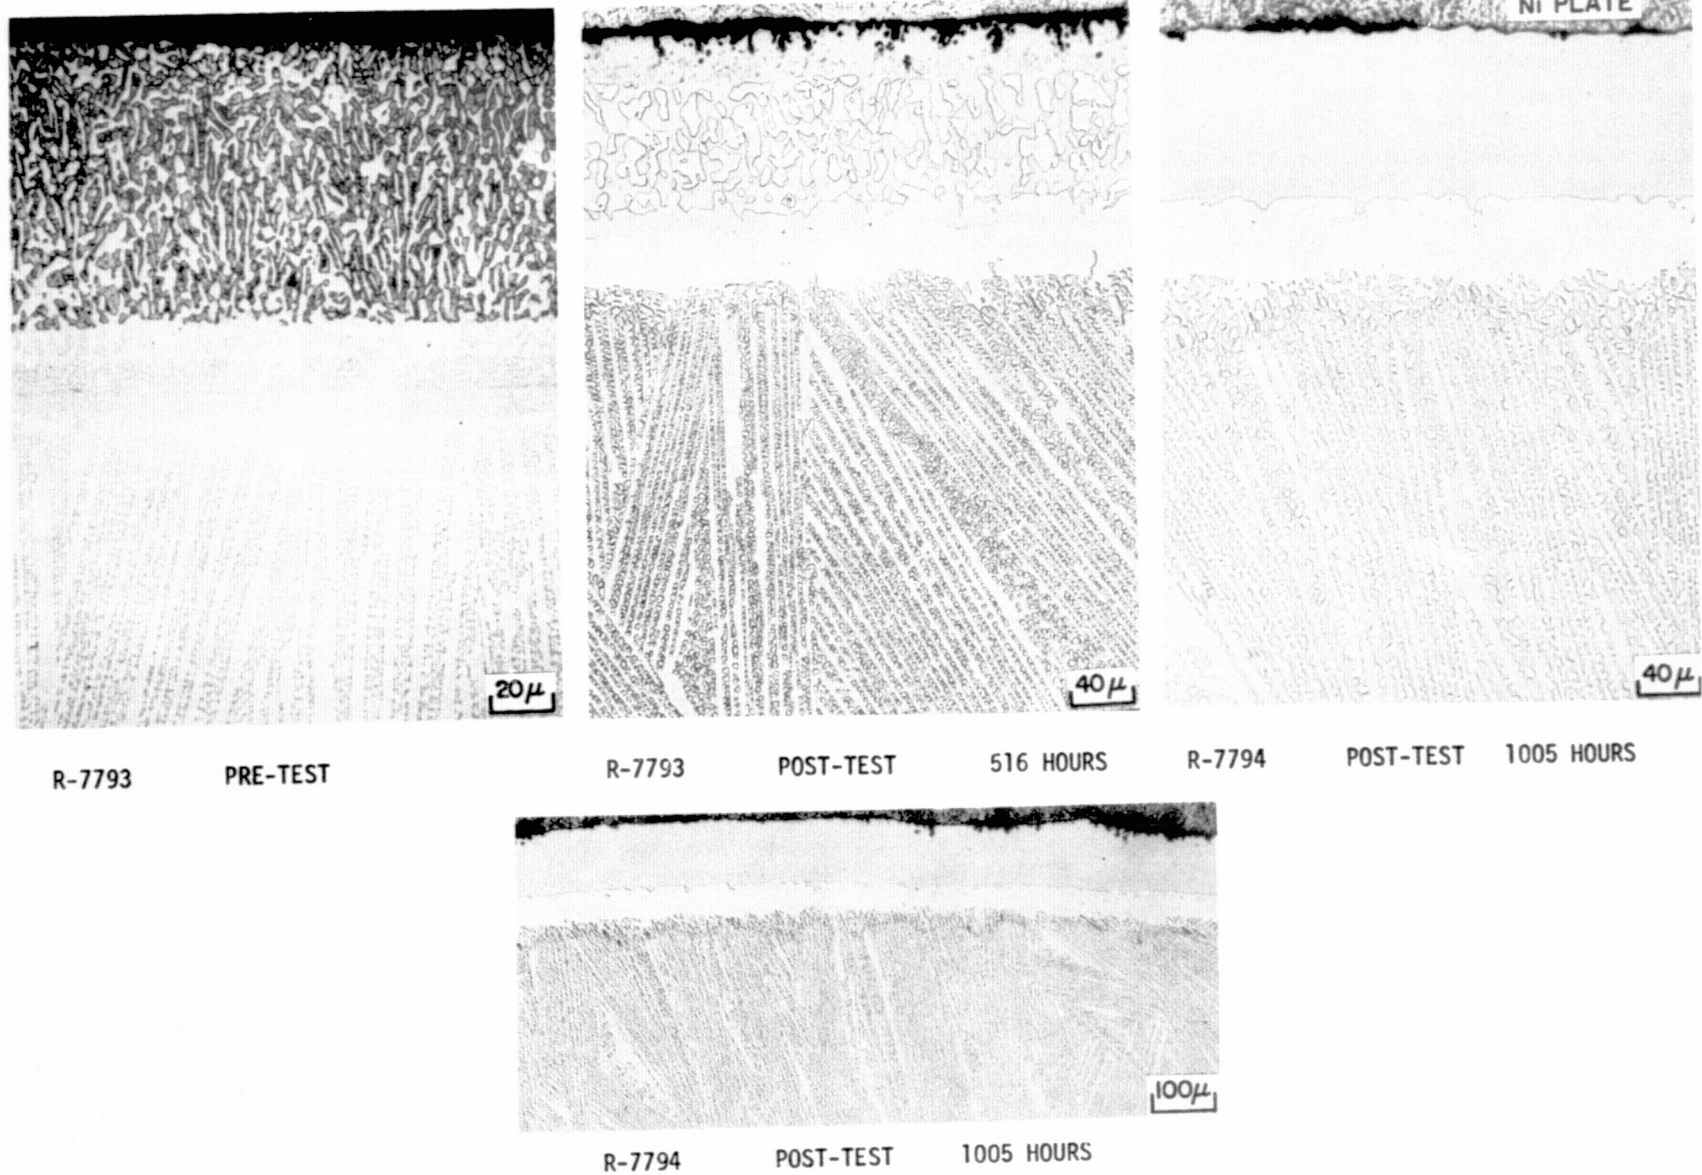
Figure 31 Pretest and Post-Test Microstructures of NiCrAlY Coated  $\gamma/\gamma'$ - $\delta$  Specimens After 516 and 1005 Hours of Evaluation in 1366 K (2000°F) Burner Rig Cyclic Oxidation Test (Cycle: 55 Minutes Hot – 5 Minutes Forced Air Cool). (K-20924)

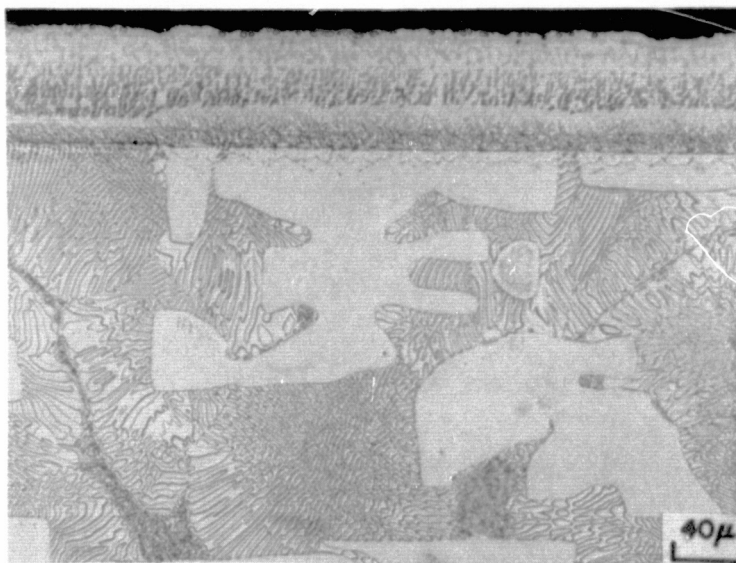
*Figure 36 (A) Pretest and (B) Post-test Microstructures of  $\gamma/\gamma'$ - $\delta$  Eutectic Alloy Coupons Coated with Approximately 63  $\mu$  of Ni-23Co-18Cr-12.5Al-0.3Y By Electron Beam Vapor Deposition and Then Sputter Coated with Approximately 6  $\mu$  of Platinum. The Coated  $\gamma/\gamma'$ - $\delta$  Coupon Was Evaluated for 250 Cycles in the 1172 K (1650°F) Cyclic Hot Corrosion Test. (K-13328)*

Metallographic examination of the NiCoCrAlY (Figure 35) and NiCoCrAlY + Pt (Figure 36) coated  $\gamma/\gamma' - \delta$  specimens confirmed impressions obtained by visual examination. The coating microstructures were not significantly affected by reaction with the hot salt.

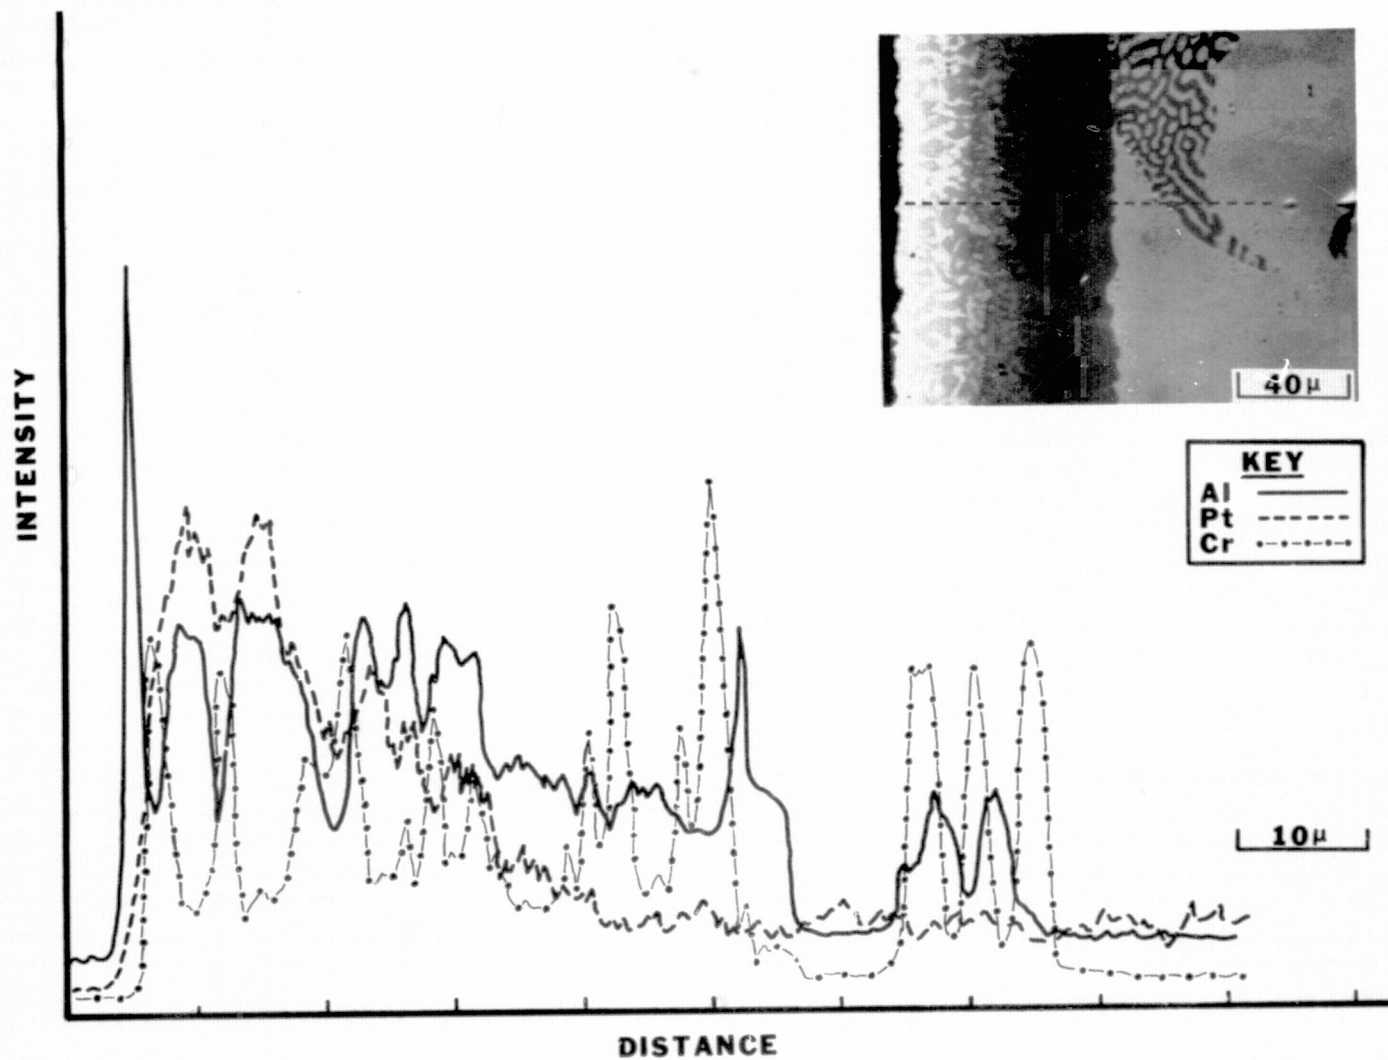
Figure 38 Relative Aluminum, Platinum and Chromium X-Radiation Intensities for As-Coated D.S.  $\gamma/\gamma'$ - $\delta$  Eutectic Alloy. The Coating Consists of 63  $\mu$  of Electron Beam Vapor Deposited Ni-18Cr-12Al-0.3Y Plus 6  $\mu$  Sputtered Platinum. (K-15106)

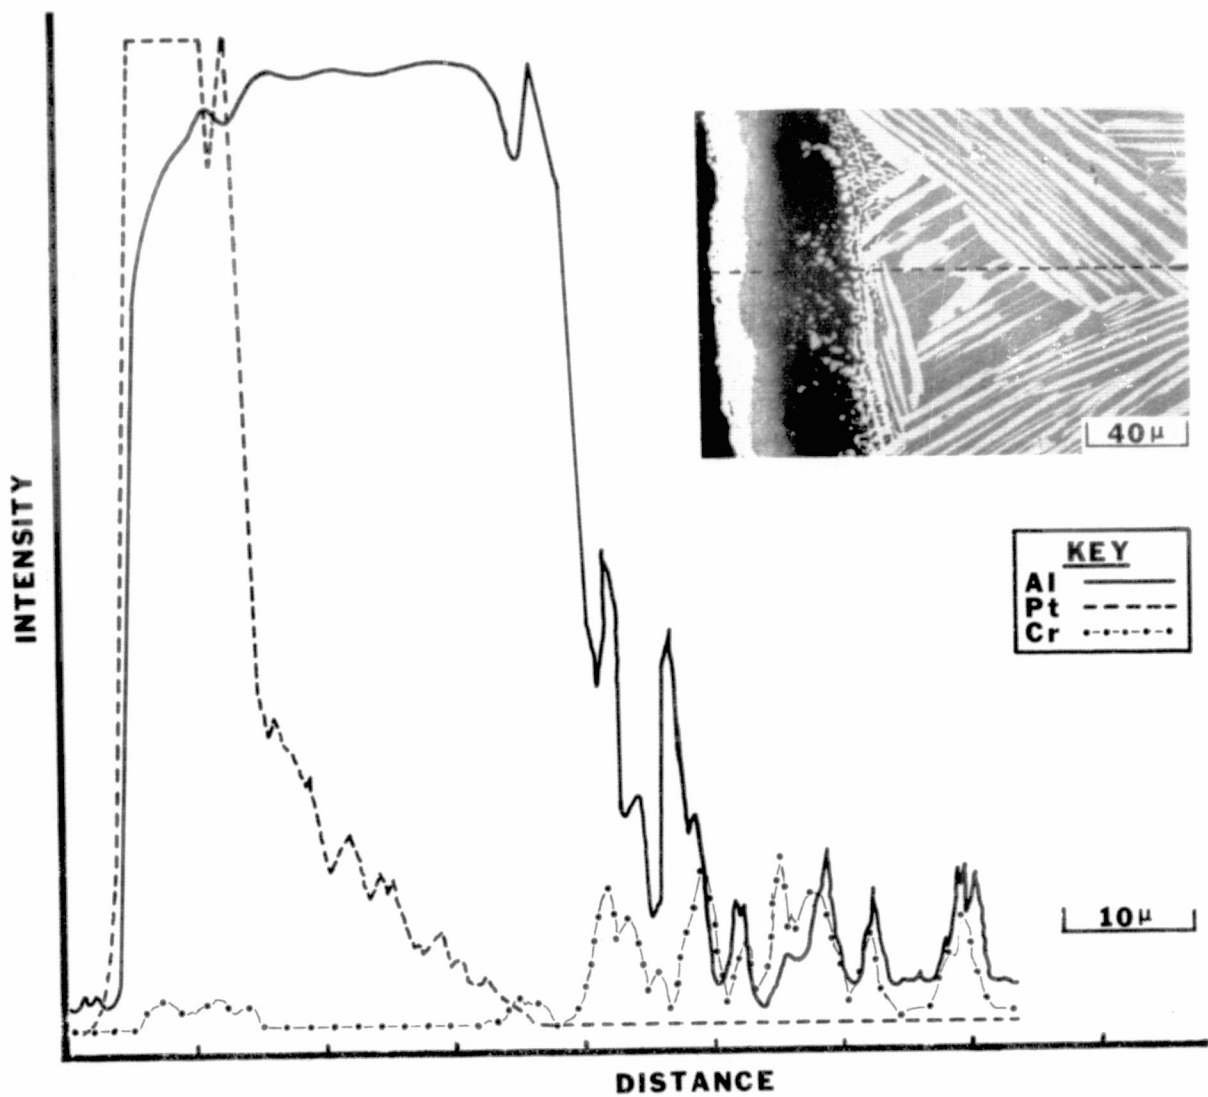
Figure 40 Relative Aluminum, Platinum and Chromium X-Radiation Intensities for As-Coated D.S.  $\gamma/\gamma'$ - $\delta$  Eutectic Alloy. The Coating Consists of 6  $\mu$  Sputtered Platinum Plus 25 to 76  $\mu$  Diffusion Aluminide. (K-15105)

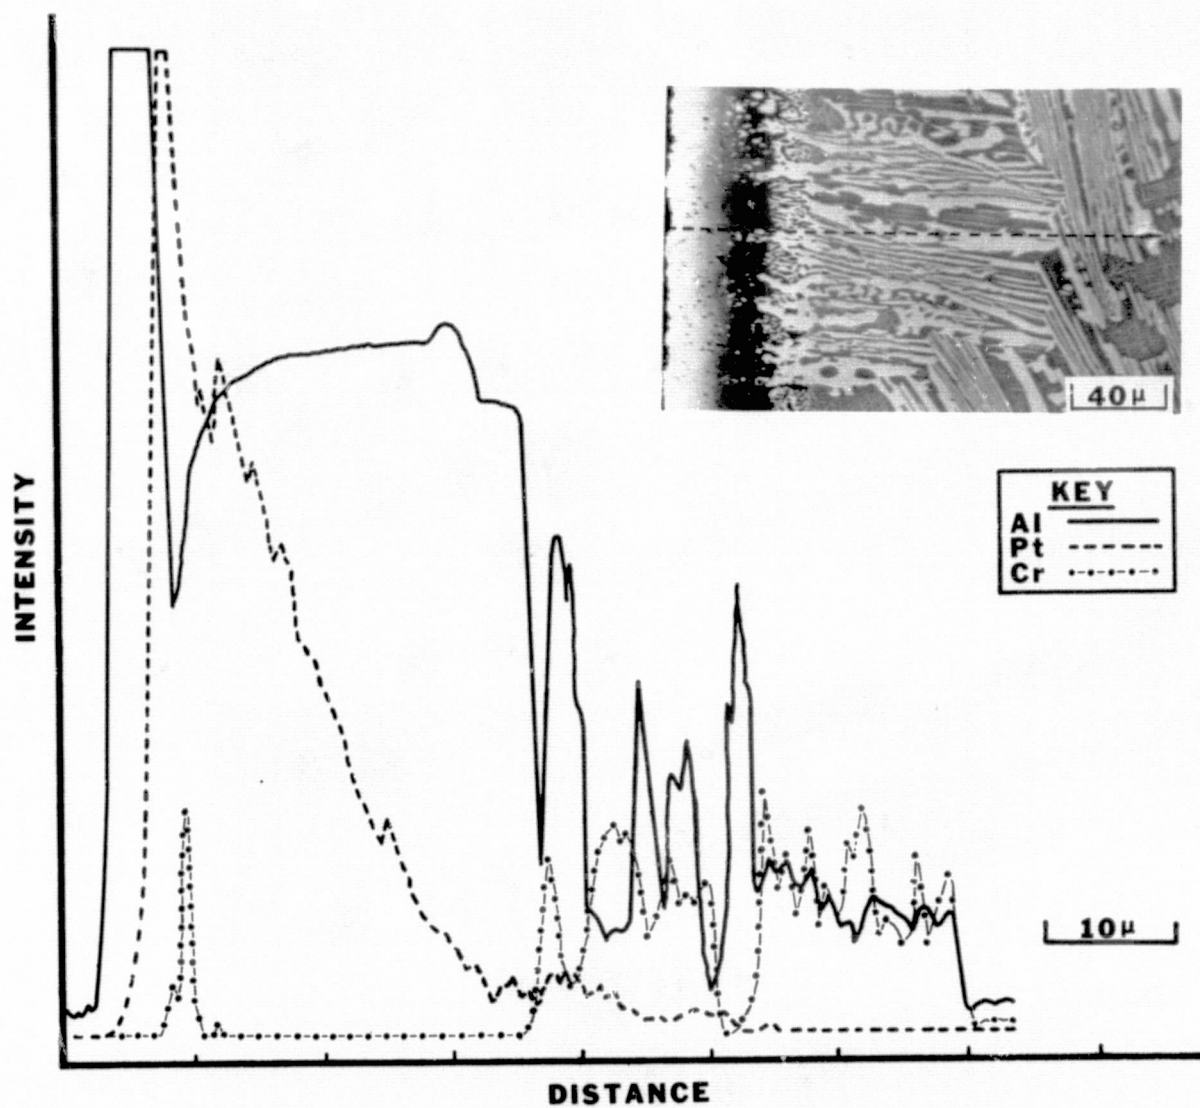
Figure 41 Relative Aluminum, Platinum and Chromium X-Radiation Intensities of Coated D.S.  $\gamma/\gamma'$ - $\delta$  Eutectic Alloy After a 1172 K (1650°F) Laboratory Hot Corrosion Test. The Coating Consists of 6μ Sputtered Platinum Plus 25 to 76μ Diffusion Aluminide. (K-15107)

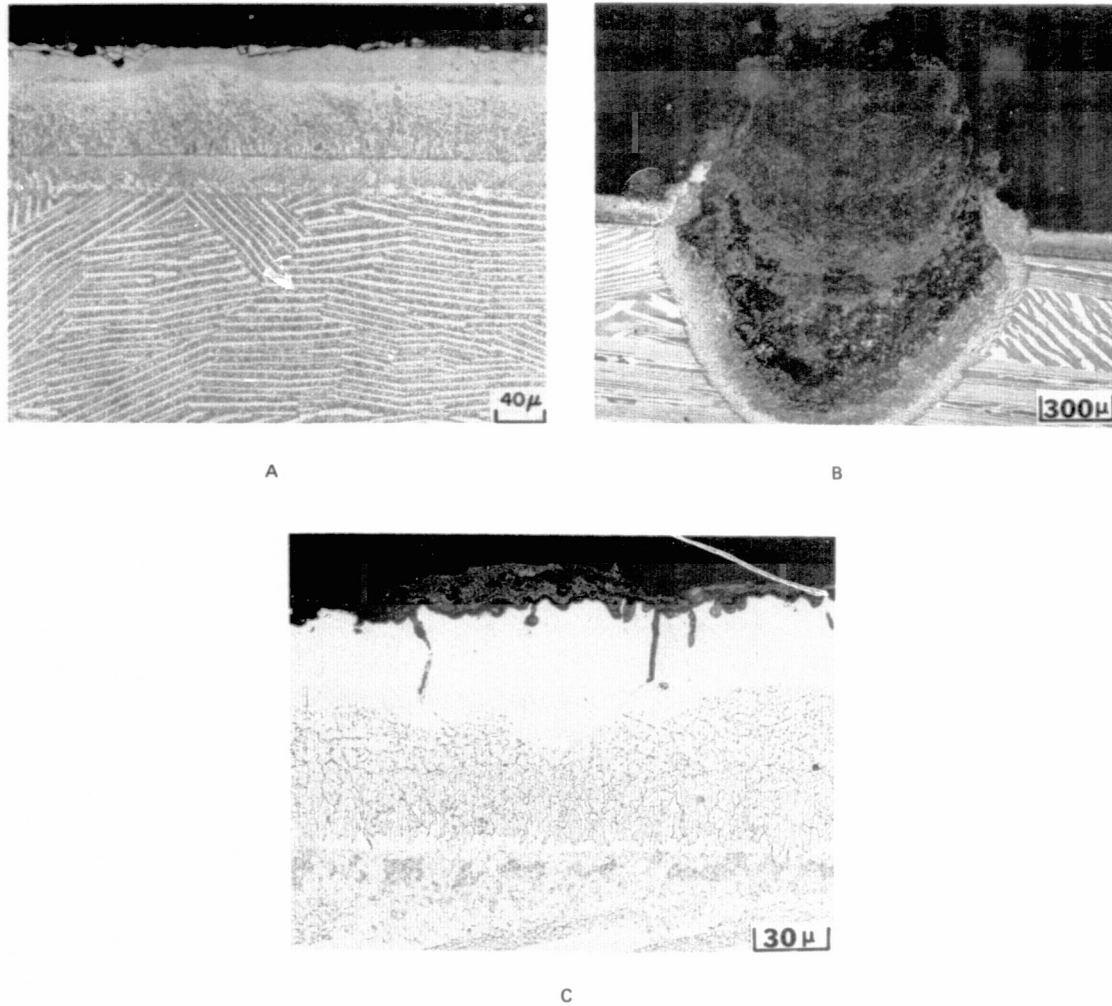
**Figure 43** (A) Pretest and (B, C) Post-test Microstructures of  $\gamma/\gamma'$ - $\delta$  Eutectic Alloy Coupons Coated with Approximately 127 μ of Ni-18Cr-5Al-0.3Y And Then Diffusion Aluminized (Pack, Outward). The Coated  $\gamma/\gamma'$ - $\delta$  Coupon Was Evaluated for 140 Cycles In The 1172 K (1650°F) Cyclic Hot Corrosion Test. (K-13333 and K-13332)

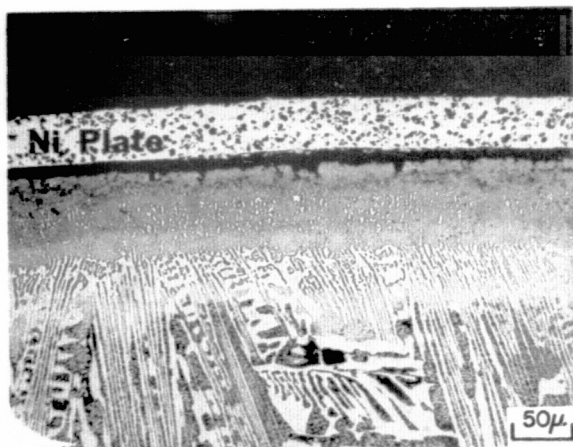
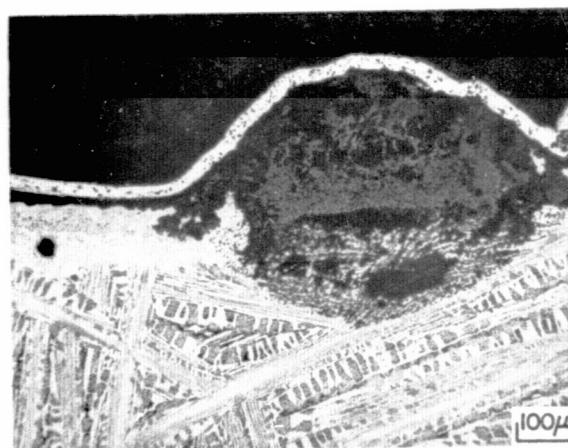
**Figure 45** *Post-test Microstructure of Gas Phase Aluminide Coated  $\gamma/\gamma'$ - $\delta$  Simulated Air Cooled Blade Specimen After 20 Hours of Cyclic Hot Corrosion Testing At 1172 K (1650°F). (A) Typical Coating Microstructure in Unfailed Regions. (B) Localized Pitting Attack of The Coating. (C) Oxide Blister and Associated Substrate Attack.*

Visual examination of the gas phase aluminide coated  $\gamma/\gamma' - \delta$  specimens indicated that local coating failures were initiated during the first 20 cycles (Figure 33). Testing of the duplicate specimens for each of the two process variations was continued to 40 cycles; at that point, the test was terminated. Metallographic examination of the specimens showed that the coating had failed in localized areas with up to  $125\mu$  of base metal attack. Figure 45 shows the formation of an oxide blister which occurred when hot corrosion attack reached the  $\gamma/\gamma' - \delta$  substrate. The coating microstructure representative of unfailed regions is also provided in this figure.

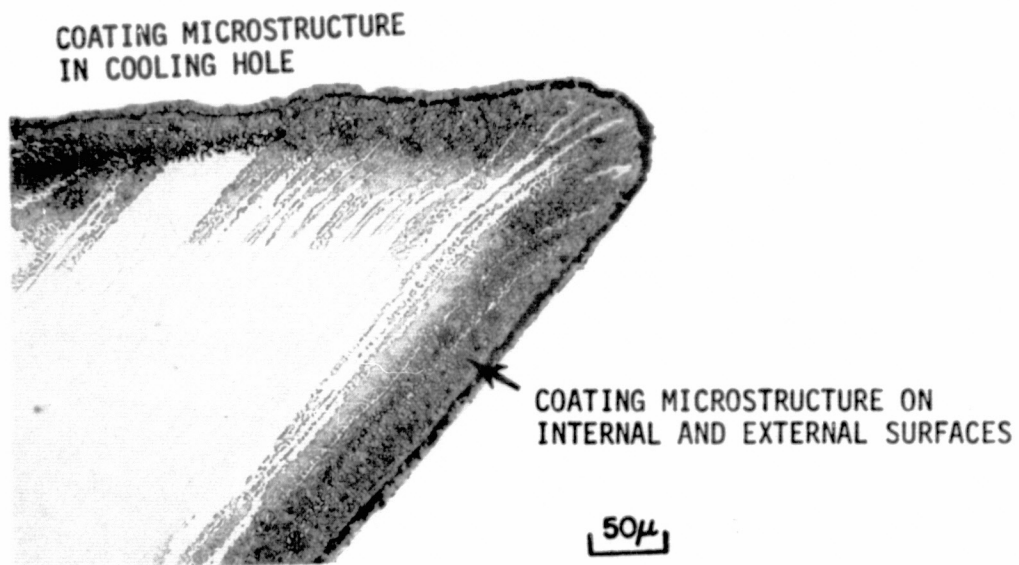
Figure 49 Typical PWA 275 Coating Microstructure at Junction of ECM Cooling Hole and Internal and External Surfaces of  $\gamma/\gamma'$ - $\delta$  Simulated Air Cooled Blade Specimen (Run 6). (K-20926)

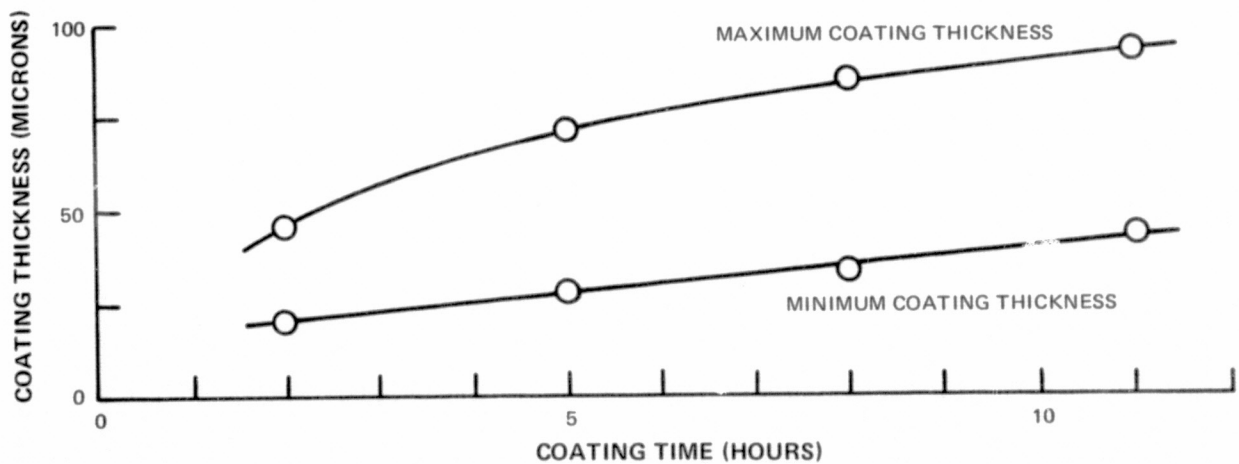
Figure 50 Thickness of PWA 275 Coating on Internal and External Surfaces of  $\gamma/\gamma'$ - $\delta$  Eutectic Alloy Specimen as a Function of Coating Time at 1366 K (2000°F)

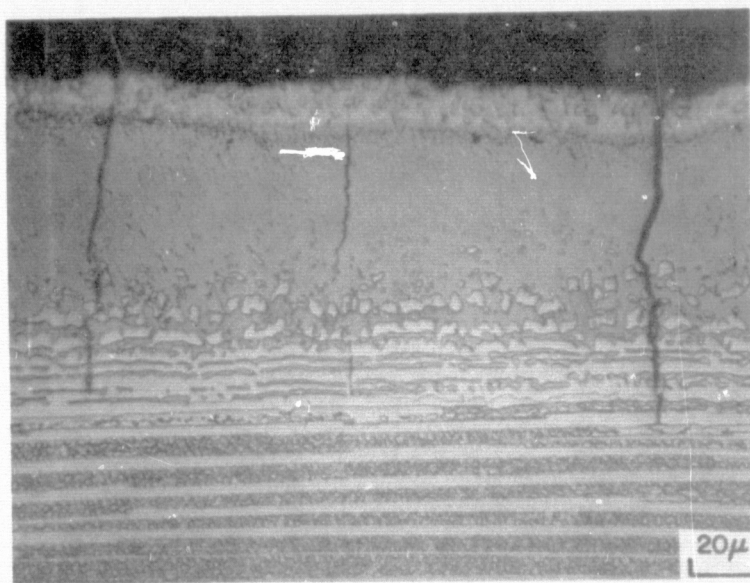
Figure 52 Post-Test Microstructure of Pt + Al Coated  $\gamma/\gamma' - \delta$  Tensile Ductility Specimen Showing Secondary Cracking. Coating Fracture Strain, 0.5 to 0.7%; Specimen Failure Strain, 4.2%; Test Temperature, 578 K. (K-13338)

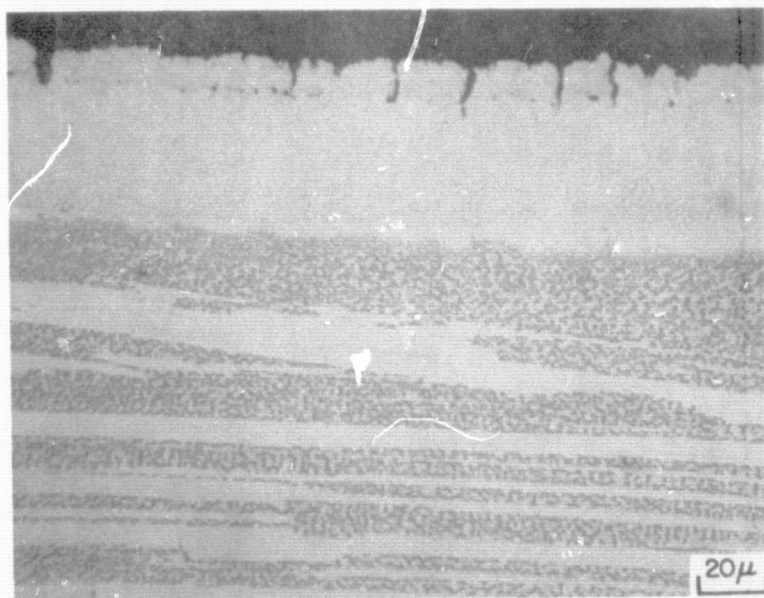
Figure 53 Post-Test Microstructure of NiCrAlY + Pt Coated  $\gamma/\gamma' - \delta$  Tensile Ductility Specimen Showing Secondary Cracking. Coating Fracture Strain, 0.5 to 0.7%; Specimen Failure Strain, 4.5%; Test Temperature, 578 K. (K-13338)

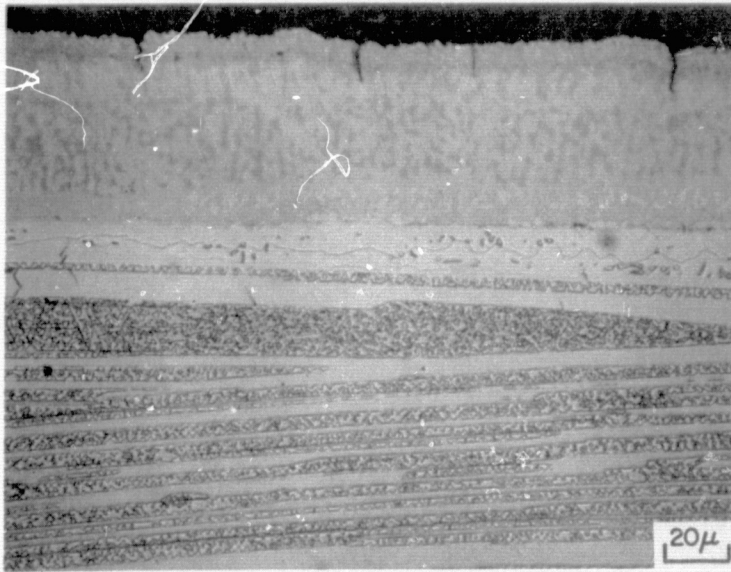
Figure 54 Post-Test Microstructure of NiCoCrAlY + Pt Coated  $\gamma/\gamma'$ - $\delta$  Tensile Ductility Specimen Showing Secondary Cracking. Coating Fracture Strain, 0.5 to 0.7%; Specimen Failure Strain, 3.1%; Test Temperature, 578 K. (K-13339)

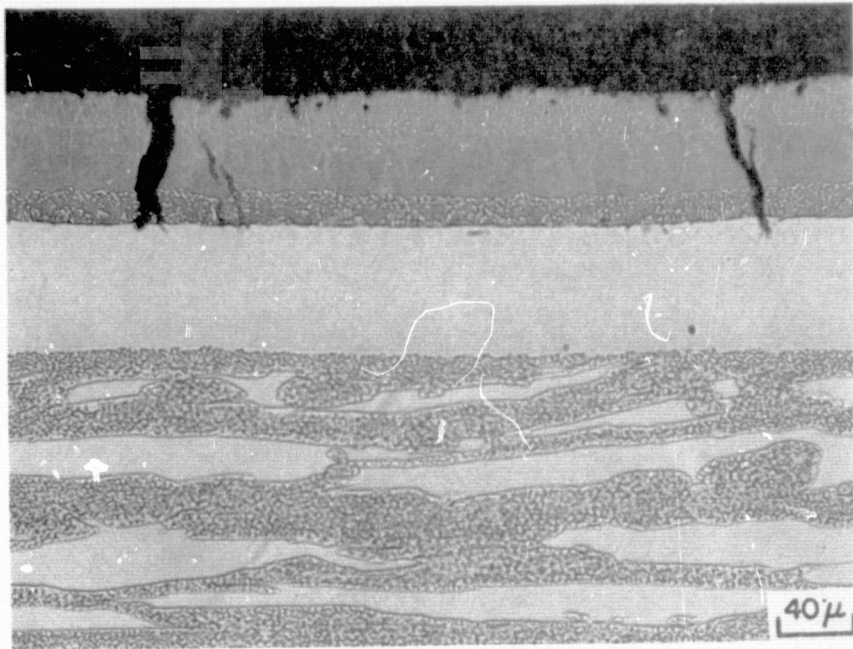
*Figure 56 Post-Test Microstructure of Low Aluminum NiCrAlY + Diffusion-Aluminide (Pack, Inward) Coated  $\gamma/\gamma'$  -  $\delta$  Tensile Ductility Specimen Showing Secondary Cracking Coating Fracture Strain, 0.2 to 0.4%; Specimen Failure Strain, 3.2%; Test Temperature, 578 K (K-13240)*

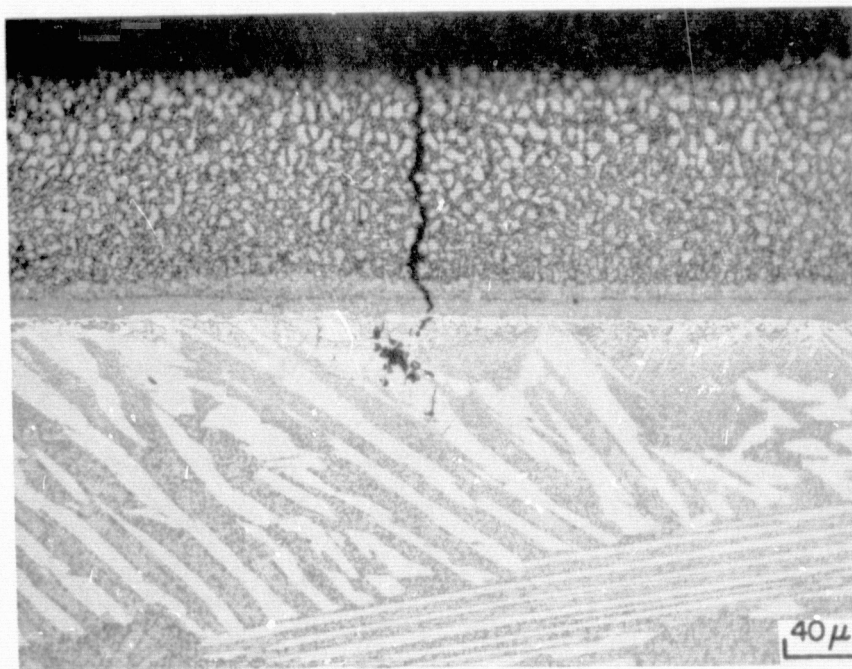
*Figure 57 Post-Test Microstructure of NiCrAlSiY Coated  $\gamma/\gamma'$  -  $\delta$  Tensile Ductility Specimen Showing Secondary Cracking. Coating Fracture Strain, 1.3 to 1.6%; Specimen Failure Strain, 1.6%; Test Temperature, 578 K.*

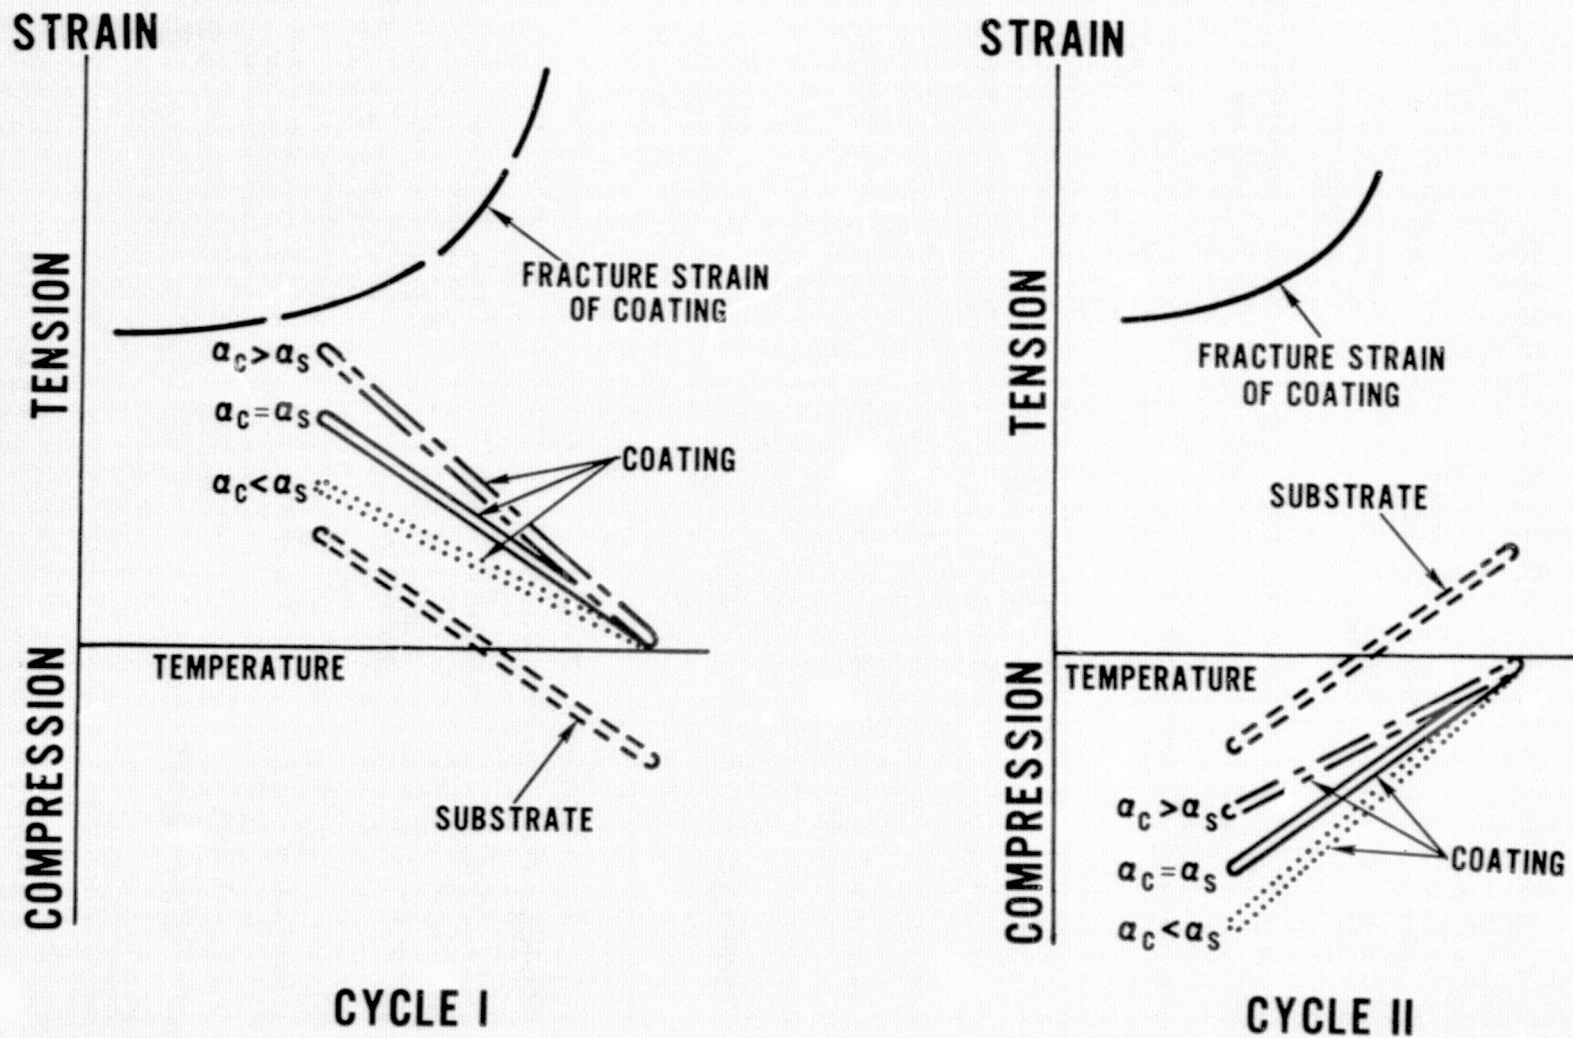
Figure 58 Schematic Relationship between Thermomechanical Fatigue Cycles in Substrate and Coating. The Zero-Strain Condition of the Coating is Set at the Maximum Temperature of the Thermomechanical Fatigue Cycle.

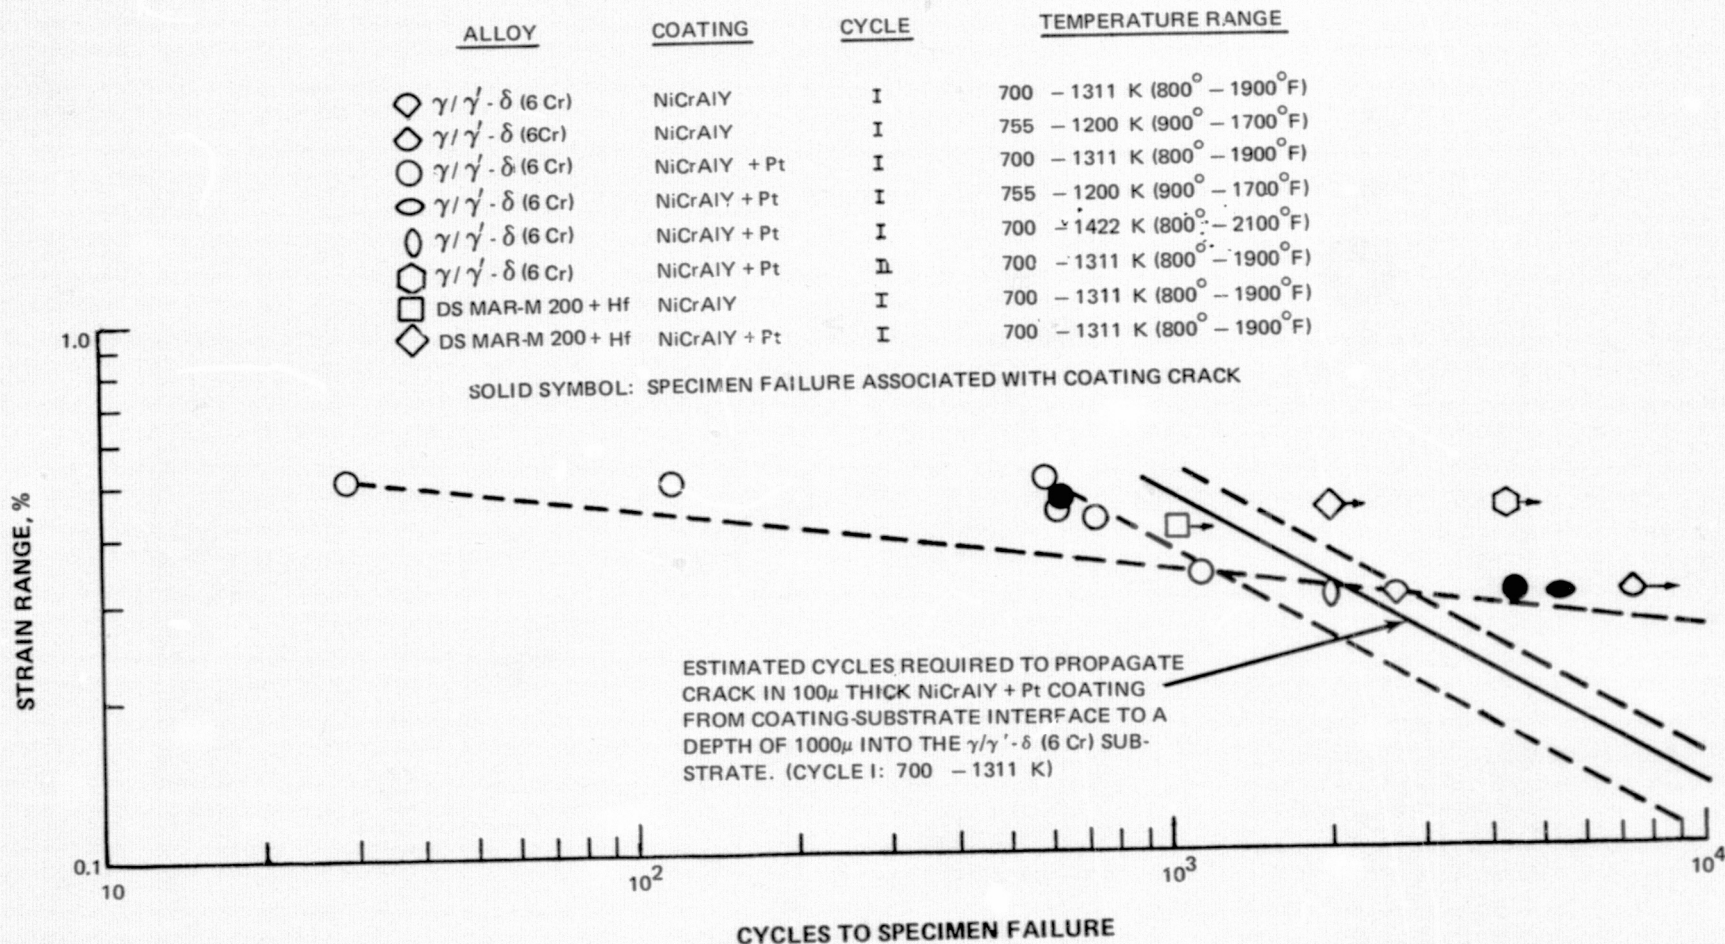
Figure 59 Thermal Fatigue Lives of NiCrAlY and NiCrAlY + Pt Coated  $\gamma/\gamma' - \delta$  and D.S. MAR-M 200 + Hf Specimens.

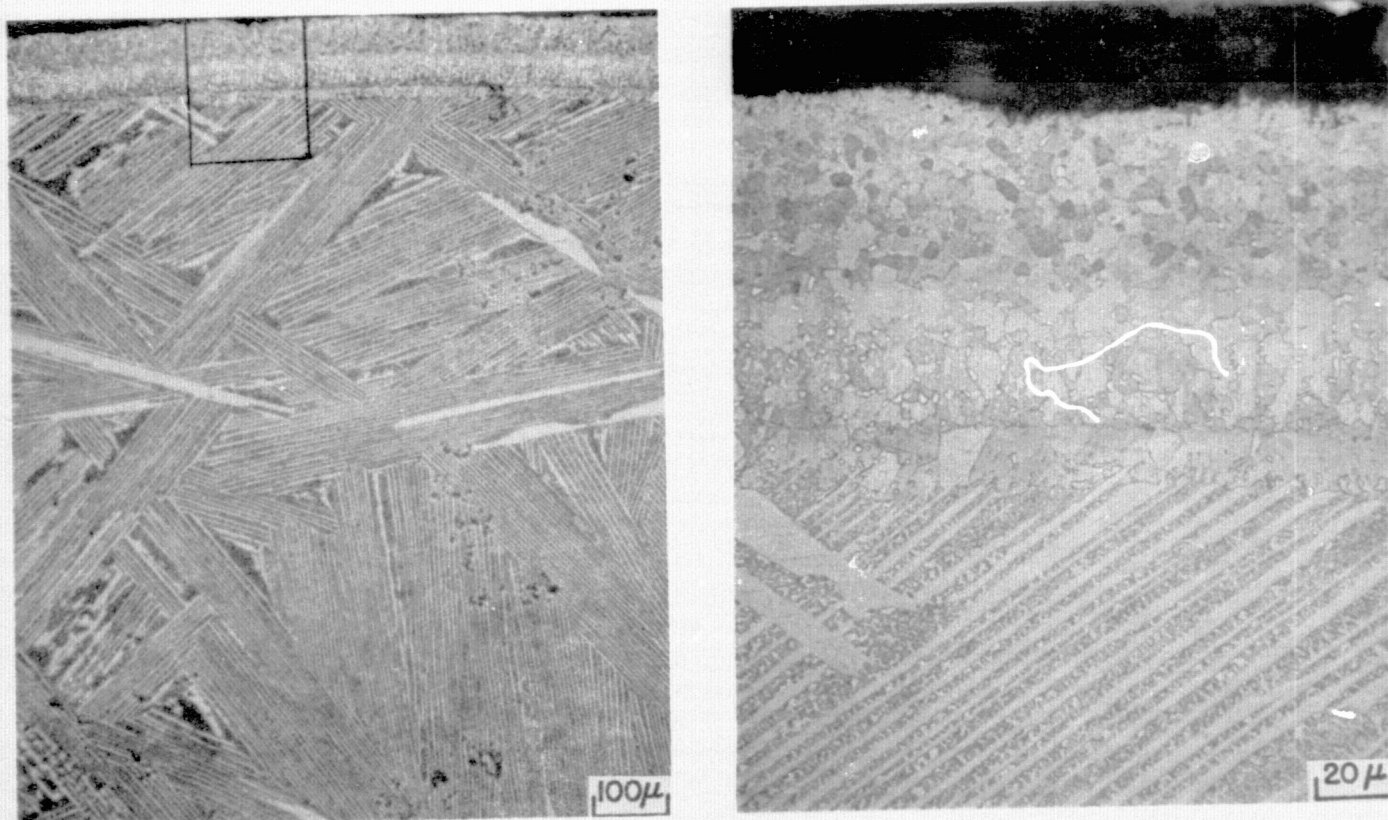
Figure 60 Microstructure of NiCrAlY Coated  $\gamma/\gamma'$  -  $\delta$  (6Cr) Specimen (E 300) which was Evaluated for 2678 Cycles in a Cycle I (700 to 1311 K;  $\Delta\epsilon_{TM} = 0.30\%$ ) Thermomechanical Fatigue Test. (K-16733)

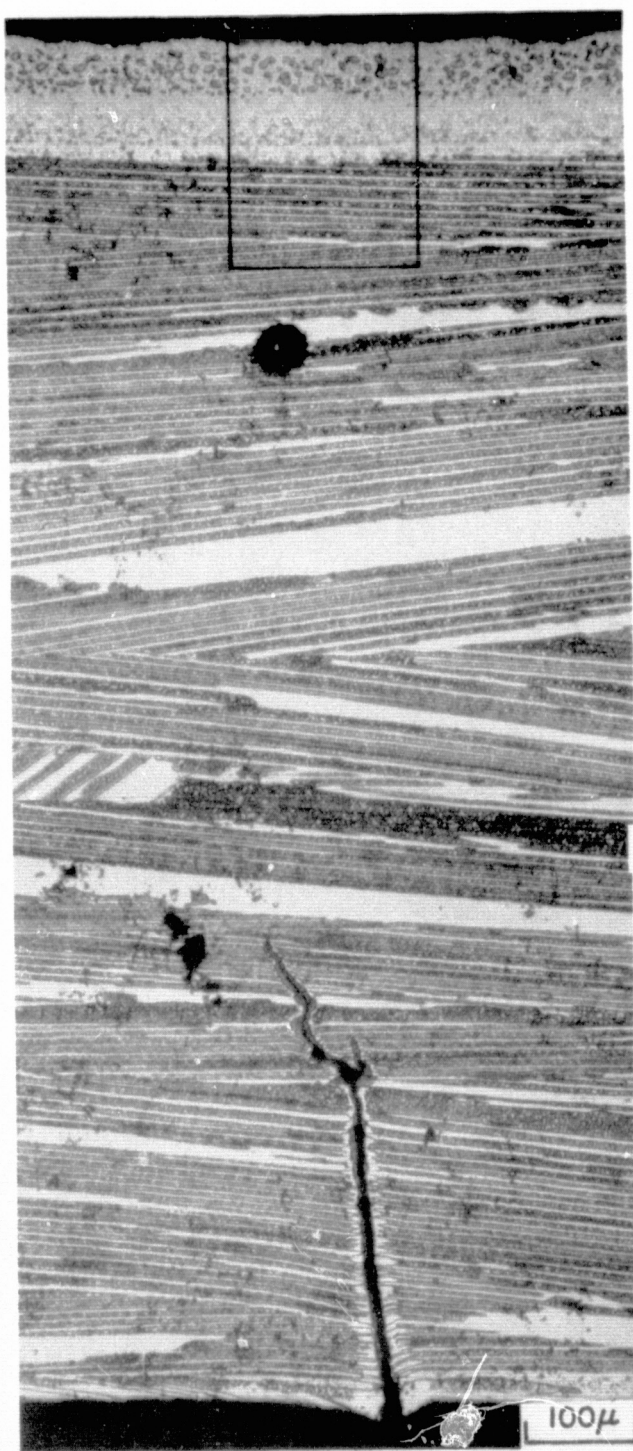
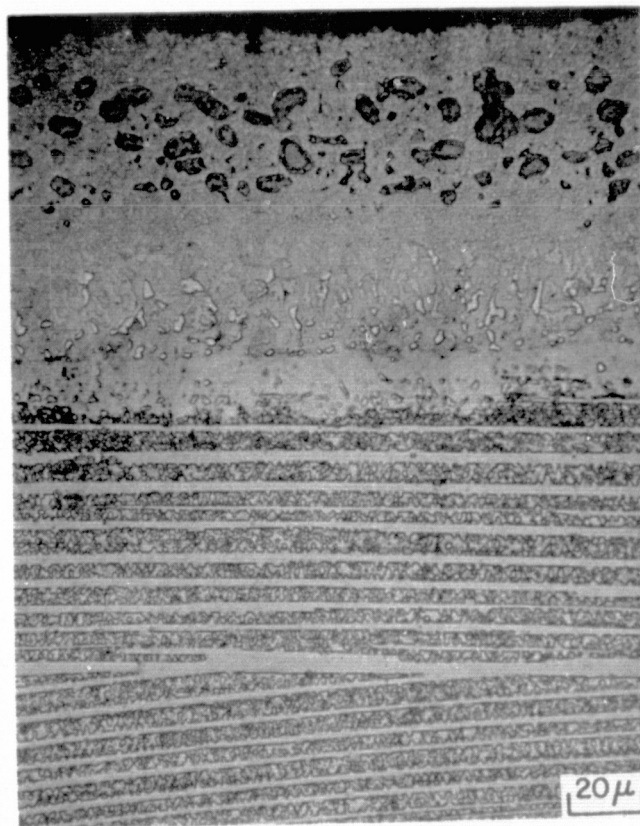
Figure 61 Longitudinal Microstructure and Secondary Crack Morphology in NiCrAlY Coated  $\gamma/\gamma' - \delta$  (6Cr) Specimen (E 300) which was Evaluated for 2678 Cycles in a Cycle I (700 to 1311 K;  $\Delta\epsilon_{TM} = 0.30\%$ ) Thermomechanical Fatigue Test. Oxide Inclusions and Substrate Porosity may have Contributed to Crack Initiation. (K-16734)

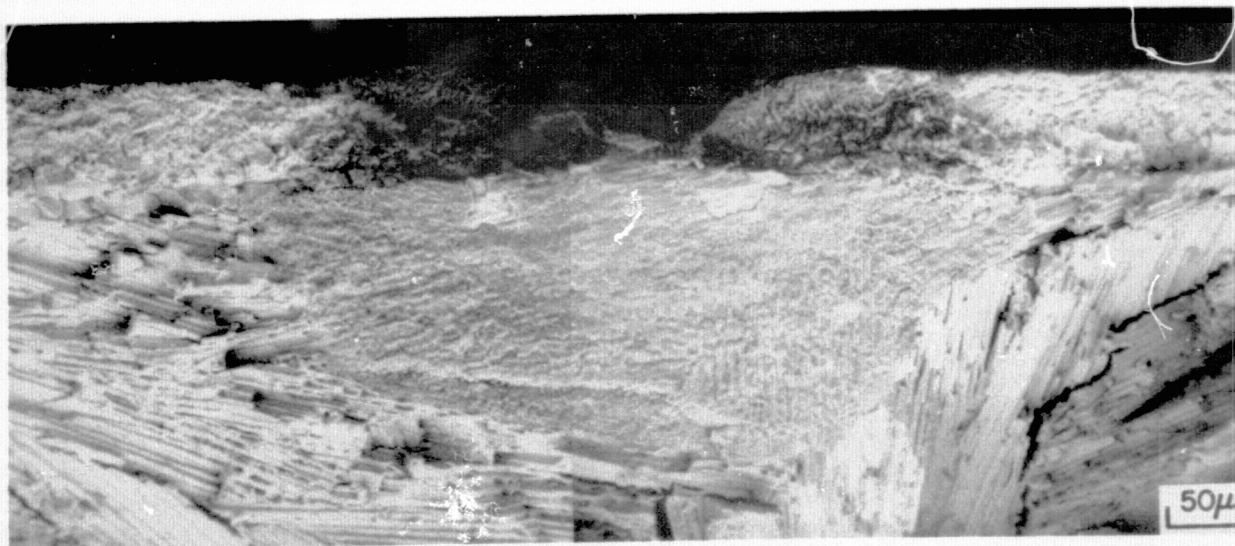
*Figure 62 Scanning Electron Microscope (SEM) Fracture Surface Photograph of Secondary Thermal Fatigue Crack in NiCrAlY Coated  $\gamma/\gamma'$  -  $\delta$  Specimen (E 300) which was Evaluated for 2678 Cycles in a Cycle I (700 to 1311 K;  $\Delta\epsilon_{TM} = 0.30\%$ ) Thermomechanical Fatigue Test. Coating Crack Initiation was Detected after Approximately 1550 Cycles. (K-16735)*

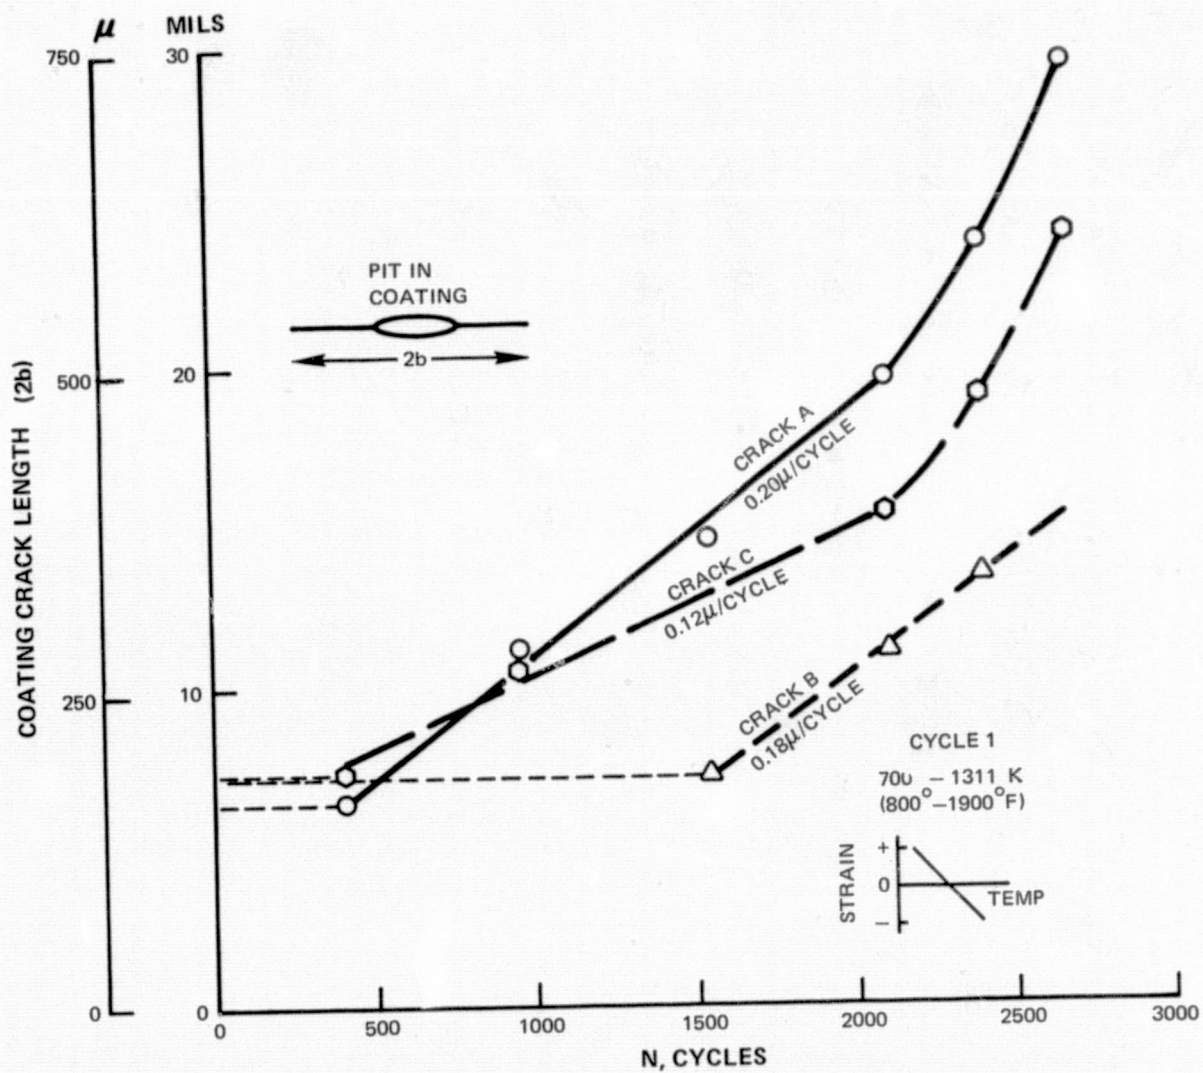
Figure 63 Surface Propagation of Thermal Fatigue Cracks in NiCrAlY Coated  $\gamma/\gamma' - \delta$  Specimen E 300 ( $\Delta\epsilon_{TM} = 0.30\%$ ).

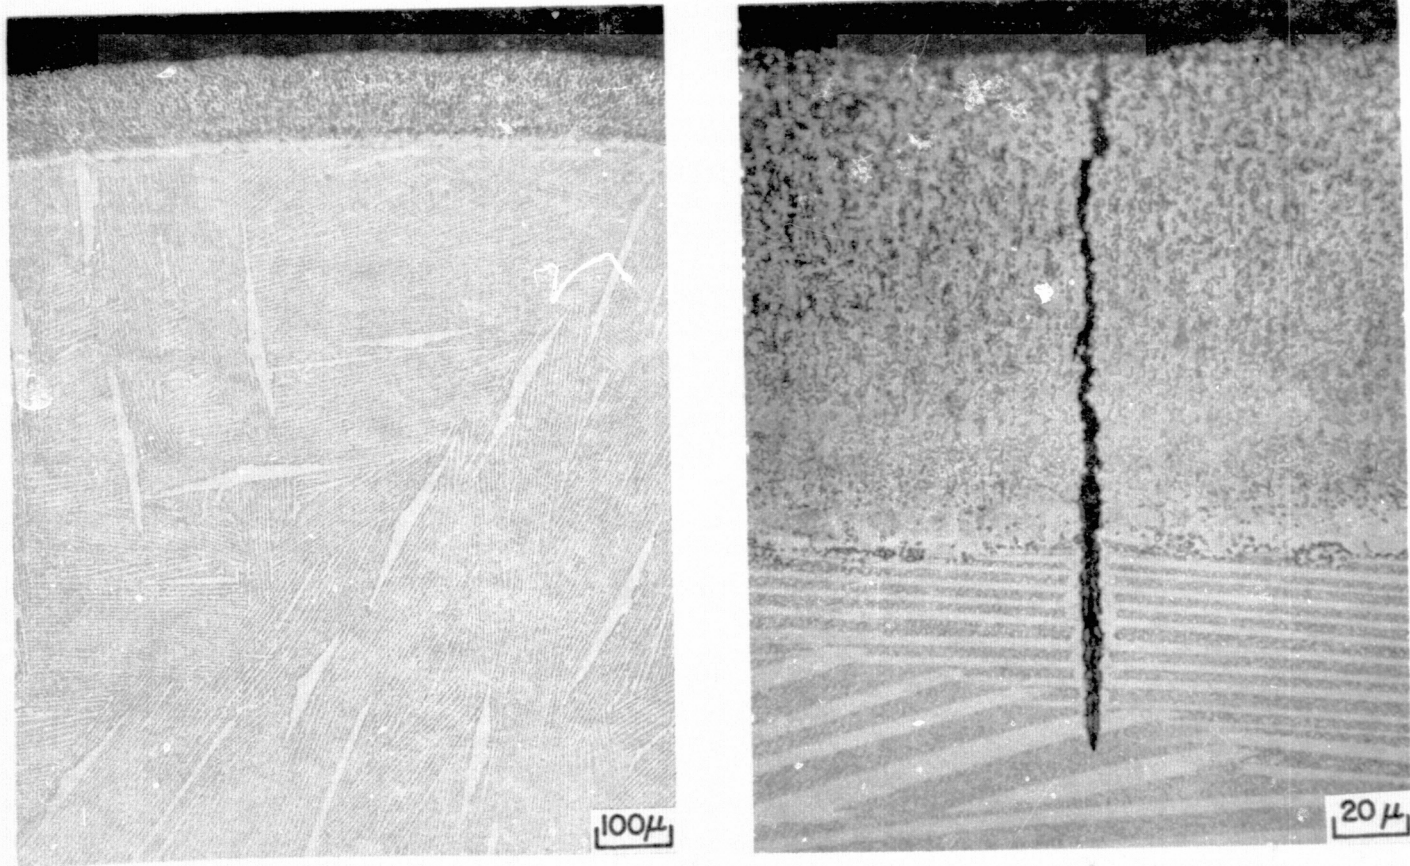
**Figure 64** *Transverse (Left) and Longitudinal (Right) Cross-Section Microstructures of NiCrAlY Coated  $\gamma/\gamma'$ - $\delta$  (6Cr) Specimen (E 487) which was Evaluated for 7286 Cycles in a Cycle I (755 to 1200 K;  $\Delta\epsilon_{TM} = 0.30\%$ ) Thermomechanical Fatigue Test. The Longitudinal Microstructure Shows a Small Thermal Fatigue Crack which has Propagated a Short Distance into the Eutectic Alloy Substrate.*
